Bricks Down the Bay: Archaeological Investigations of a Brick Tenement House Structure

Introduction

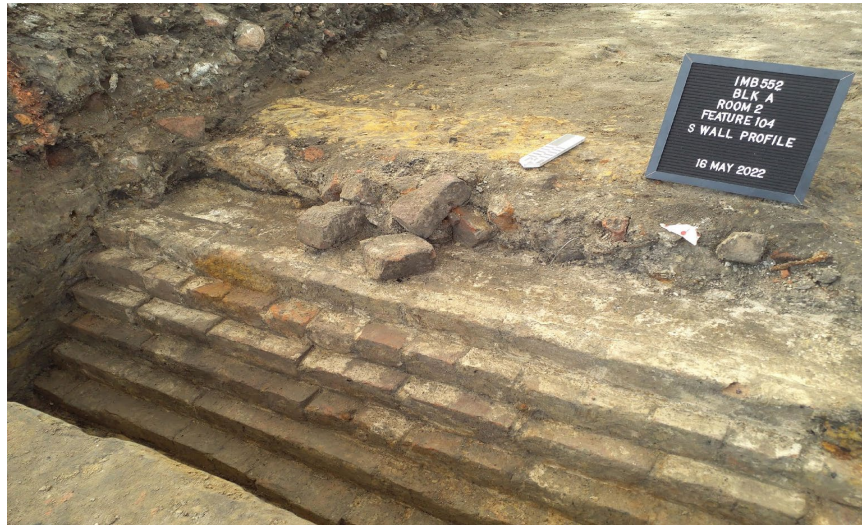
Feature 104, one of the brick walls separating Rooms 2 & 3.

Seven of the nine rooms were hand excavated. Identified features included linear articulated brickworks, including interior walls that separated rooms and the exterior walls of the structure itself.

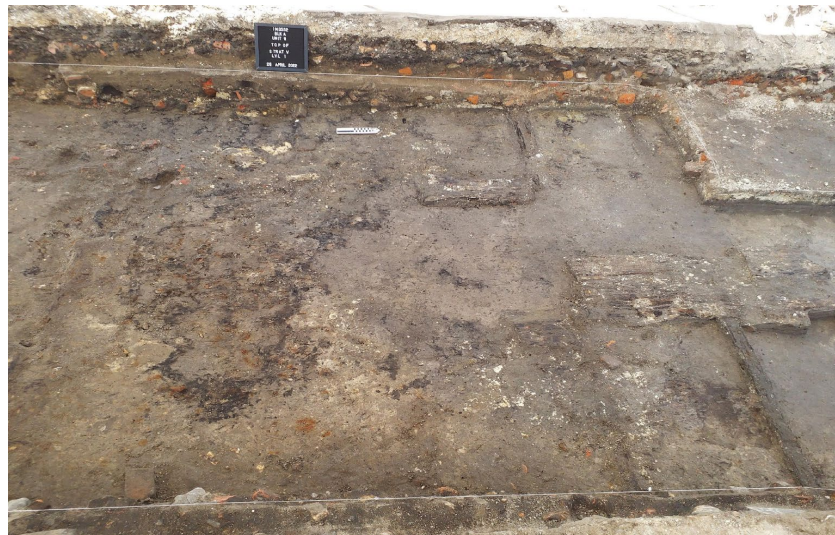
Rooms 5 & 6 at the interface of the wood floor and subfloor.

The remains of an in situ wood floor was found beneath the demolition rubble. Intermixed were plaster and mortar, as well as some possible structural cross beams that likely fell from the ceiling when the building was demolished.

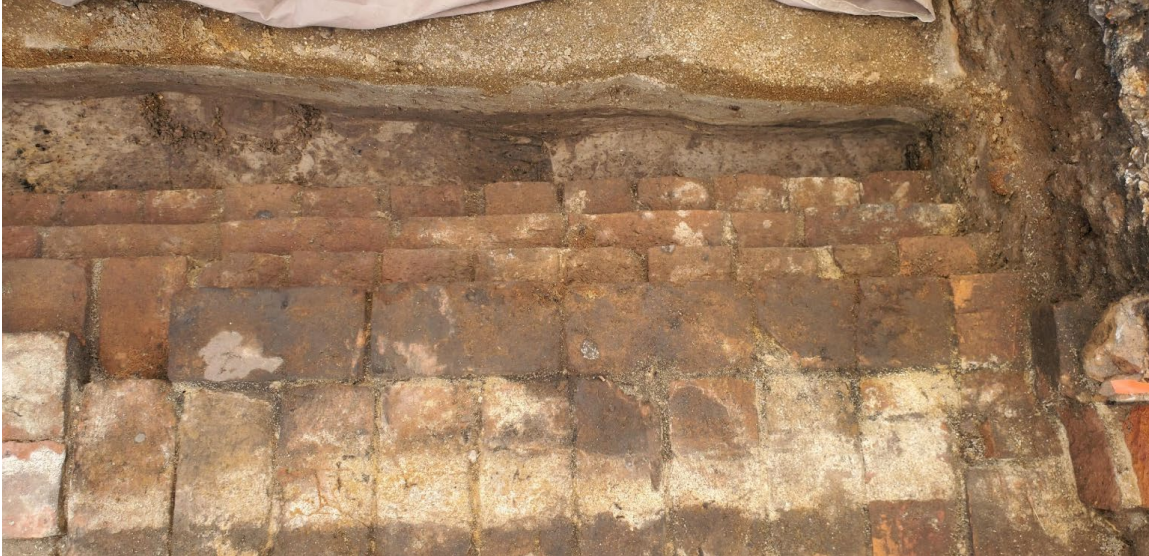
Feature 133 with crushed shell lining the Feature 104 builder's trench, possibly to prevent sinking in the sand and water table.

All of the brickwork is spread footing with a spread of coarse shell since the building is constructed on the former Mobile River marsh, a sandy substrate that is frequently inundated by the water table. The shell likely helped prevent settling of the building.

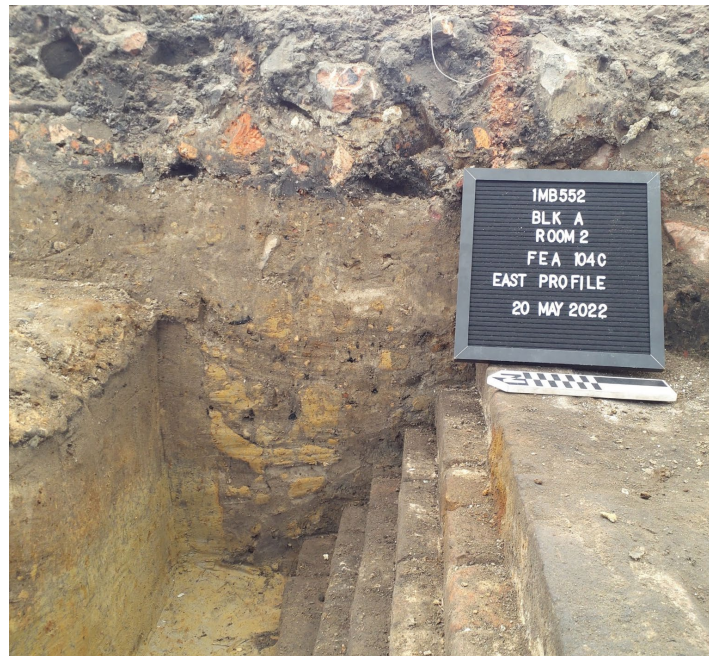
Redug builder's trench within original builder's trench between Rooms 2 & 3.

Excavations of wall features revealed episodes of remodeling and repairs. Evidence of repairs were identified along the exterior walls, possibly the result of hurricane damage. At some point, Room 3 was converted to exterior walls and that conversion is identifiable in the wall trenches and brick construction.
